Re: Bath County High School
Masonry Cracking

Structural Inspection
Bath County High School
Bath County Public Schools

Date of Inspection: January 30, 2015

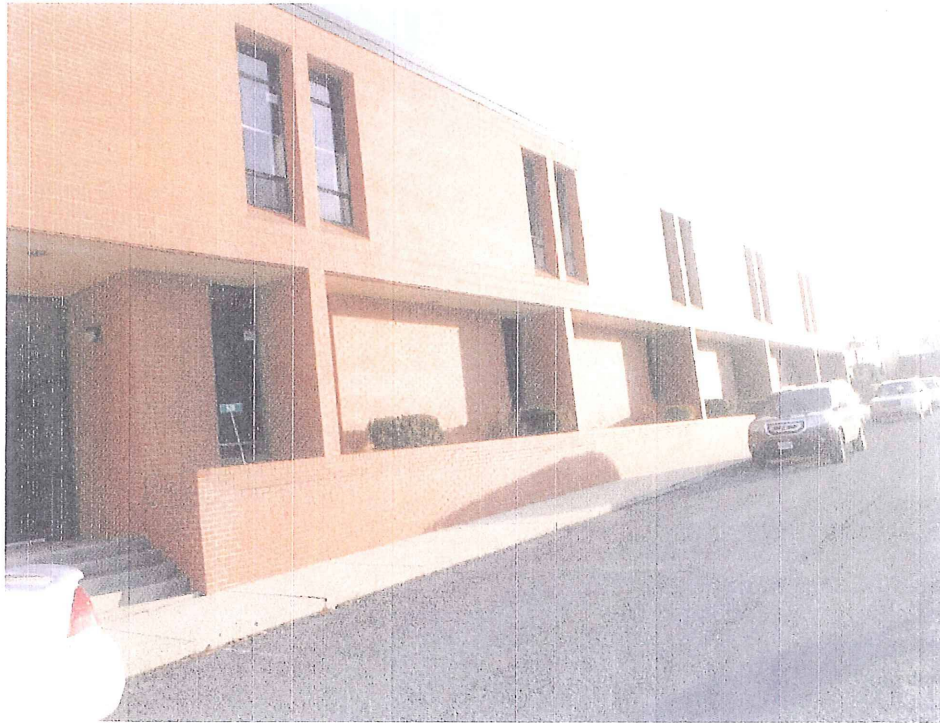
This is the front of the school. There is a beam that supports the second floor masonry just below the windows along the entire front of the structure. This beam is supported by columns located within the brick columns shown. Reviewing the design drawings, I noted that the beam is considered continuous from one end of the structure to the opposite end without any allowance for expansion and contraction. During warm weather the beam expands and in cold it contracts. This lateral movement due to this thermal expansion and contraction has created numerous cracks in the masonry as shown in the following photos.

PHOTO 1 - Front of Structure (Beam Supports Brick Just Below Windows)

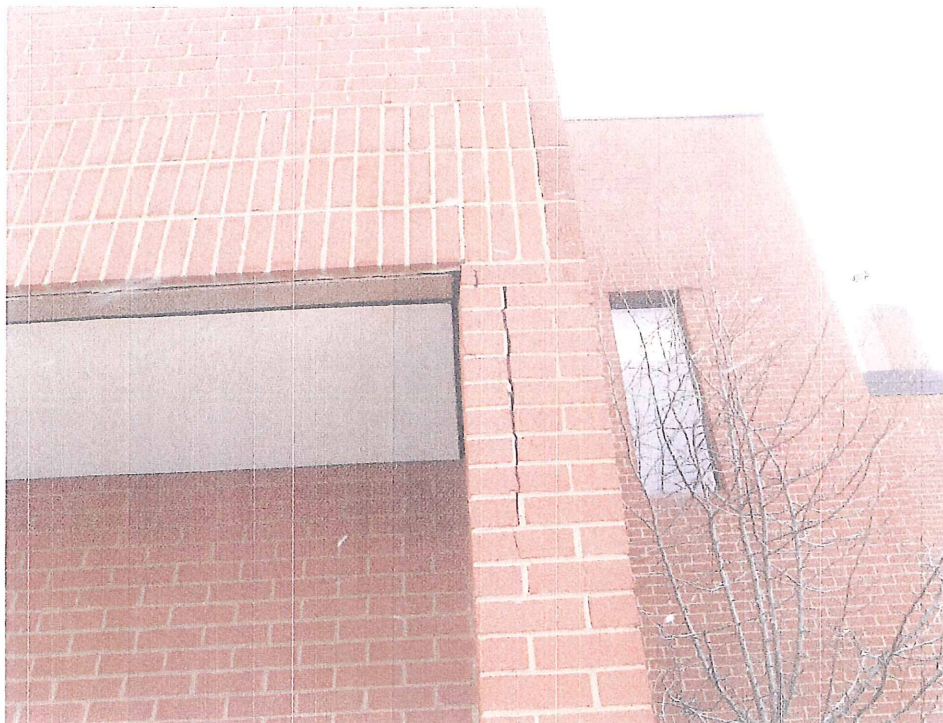
Photo 2- This is the far right had end of the front of the structure and one can see that the masonry is pushed outward. Photo 3 shows a close up of the top of the crack. Photo 4 shows a column at about mid span and the cracks at the corners indicate movement in each direction that snapped the corners off of the brick.

PHOTO 2 - Far Right Brick Column At Front Of Structure Showing Movement Due to Expansion

This is not a structural issue except for the damage to the masonry. Simply repairing the masonry will be ineffective unless some modification is made to allow the steel to expand and contract at its own pace. Water within the cavity will freeze and cause further damage and to keep the cracking from worsening. The cracks should be sealed to keep out rain. Effectively sealing these cracks without drawing attention to them is difficult. A clear silicone works well if it is placed about 1/2" below the brick surface. This will go unseen, but the cracks will still be obvious.

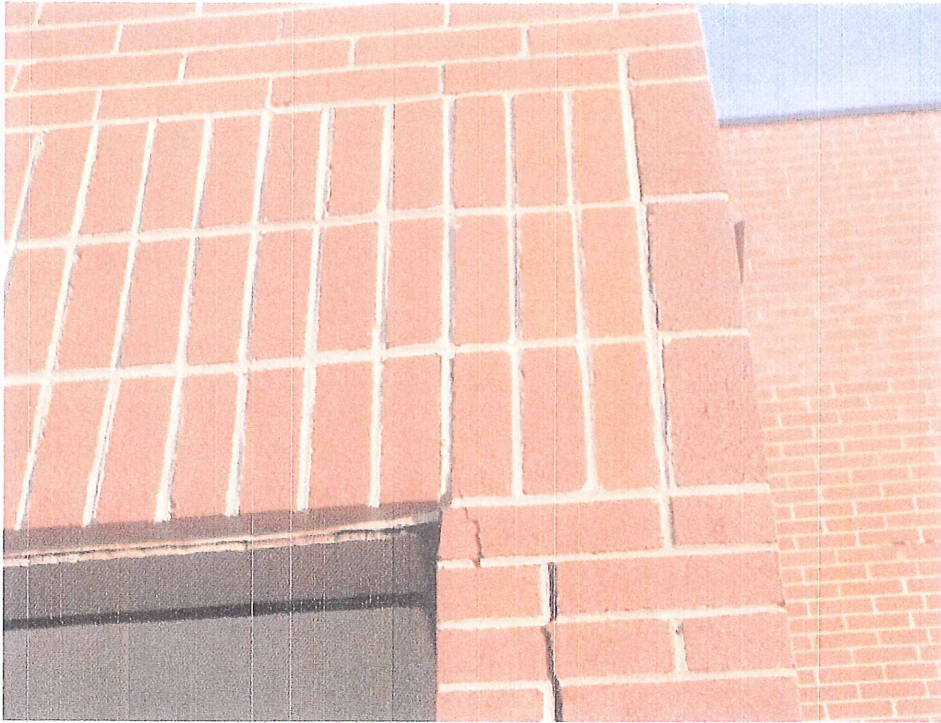
PHOTO 3 -Close Up of Crack Shown in Photo 2

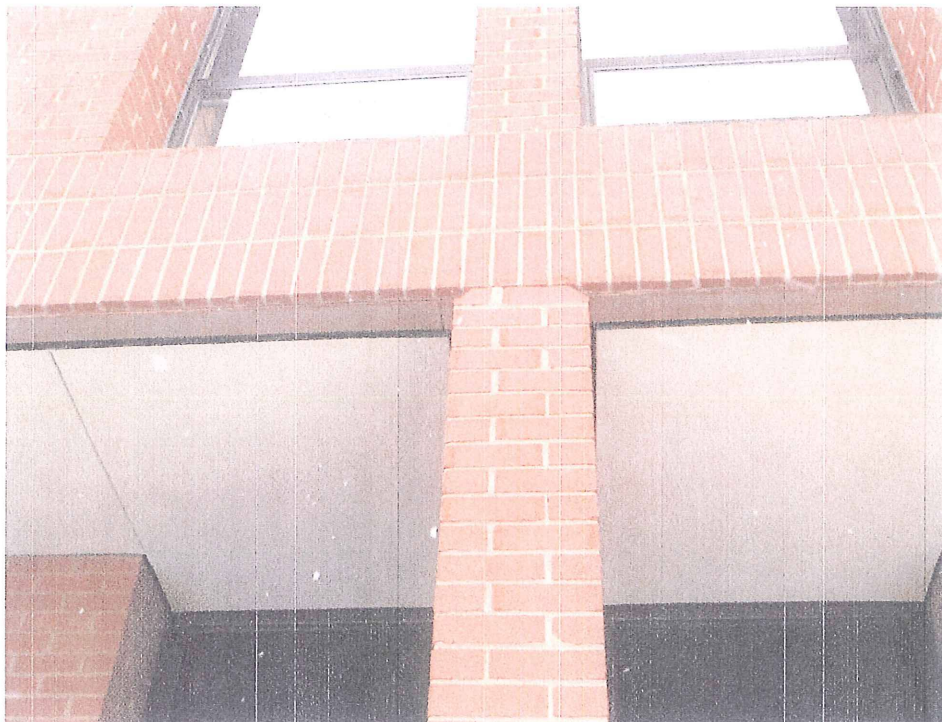
PHOTO 4 - Typical Damage Due to Thermal Expansion / Contraction of Beam

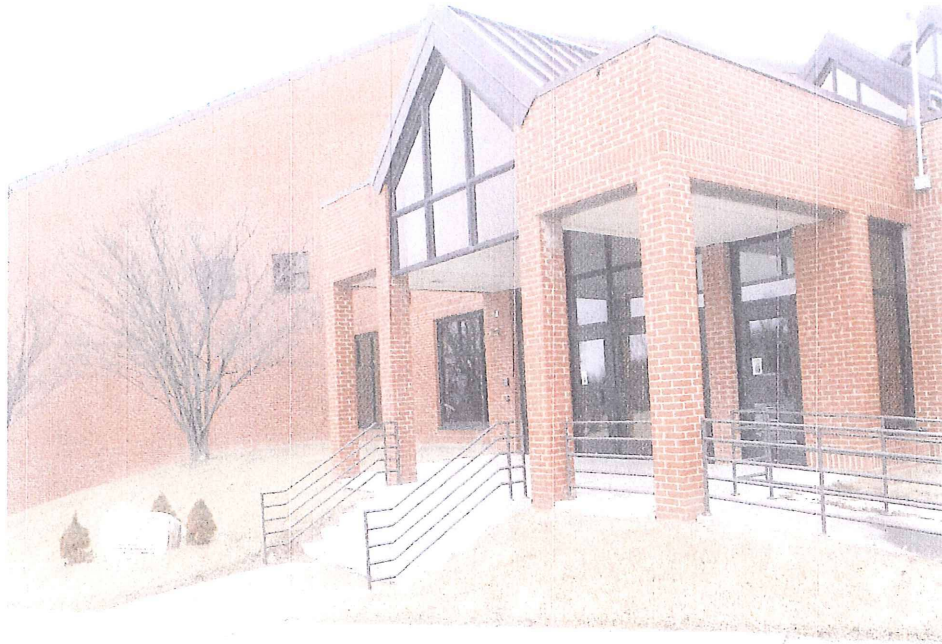
This is the rear entrance into the facility and the columns on both sides of the steps have masonry cracks that extend up from the pavement. See Photos 6 & 7. We discussed this condition and I was told that the roof above these columns had problems in the past with overflowing. It is my opinion that the moisture from this overflow soaked the lower section of the brick columns and freezing temperatures caused the water to expand within the brick cavity. The brick here could be repaired if matching brick can be found. You would need to do one side of the column at a time, and as long as the roof problem does not occur again, there should be no problem in the future.

PHOTO 5 - Brick Columns at Rear Entrance

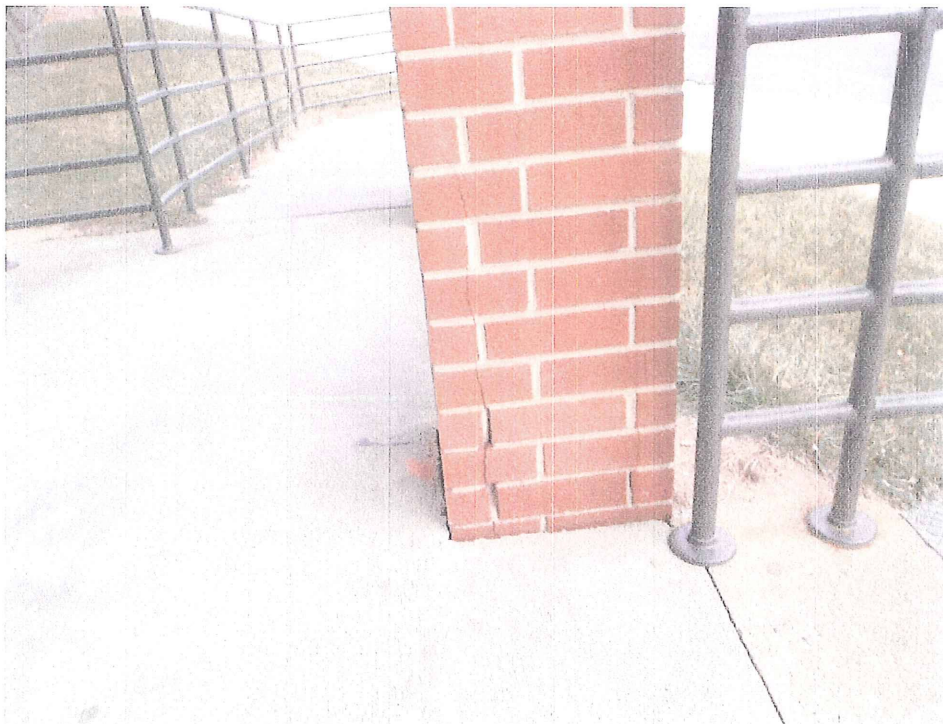
PHOTO 6 - Crack In The Left Brick Column at Stairs Shown In Photo 5

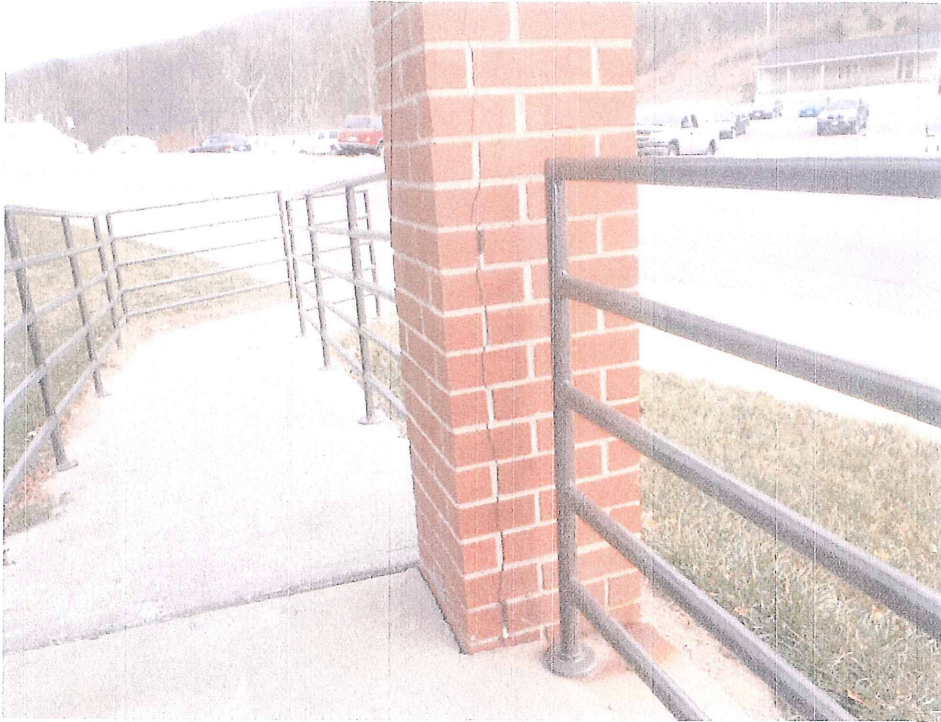
PHOTO 7 - Crack In Right Brick Column at Stairs Shown In Photo 5

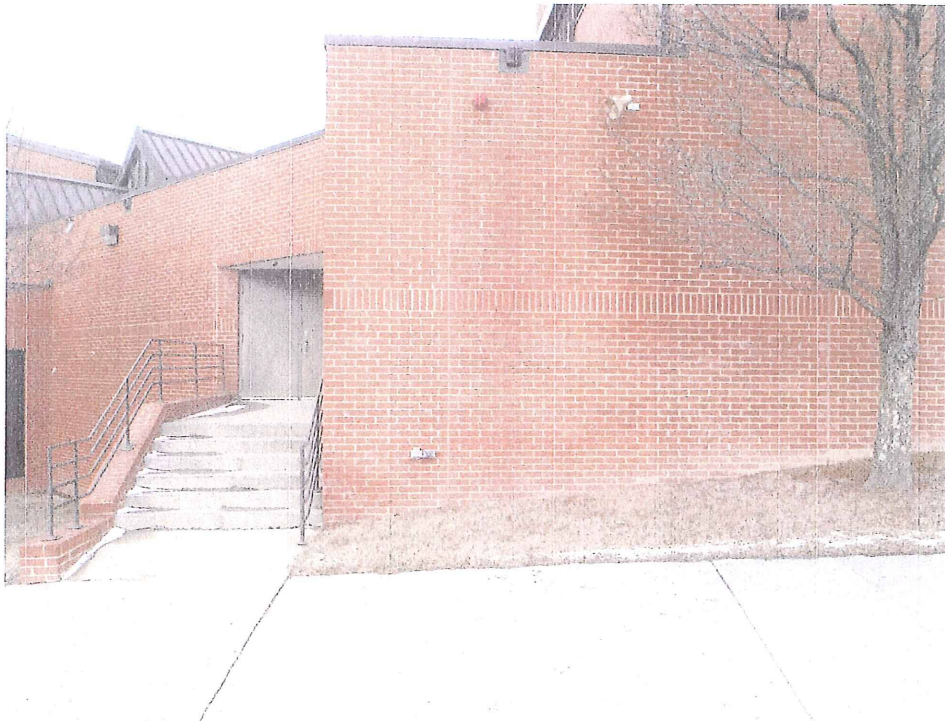
This photo shows the exterior wall opposite where the stairs that lead to the stage area in the auditorium. There were numerous cracks on the inside of the stairwell, but they did not reflect on the exterior of the structure. Photos 9 through 12 show various cracks within the stairwell. They appear to have been caused by settlement of the foundation at the corner. There are two contraction joints along the exterior of the wall and I believe these have accommodated the movement on the exterior without cracking. However, there are no expansion joints within the interior wall and any movement would show up as cracking on the interior.

PHOTO 8 - Exterior Wall At Stairs to Auditorium Stage

The repair here is fairly simple except along the sidewalk side of the structure. Should the settlement continue, I would recommend the installation of helical piers to provide additional support to the foundation. I have attached a sketch of one type of helical pier that is used for this purpose. I suggest installing crack monitors within the stairwell and recording the measurements and wait about 6 months to a year and measure them again. If the cracks have widened, I would go ahead and install the helical piers. If no movement is detected, I would recommend simply repairing the cracks on the inside and repainting the walls.

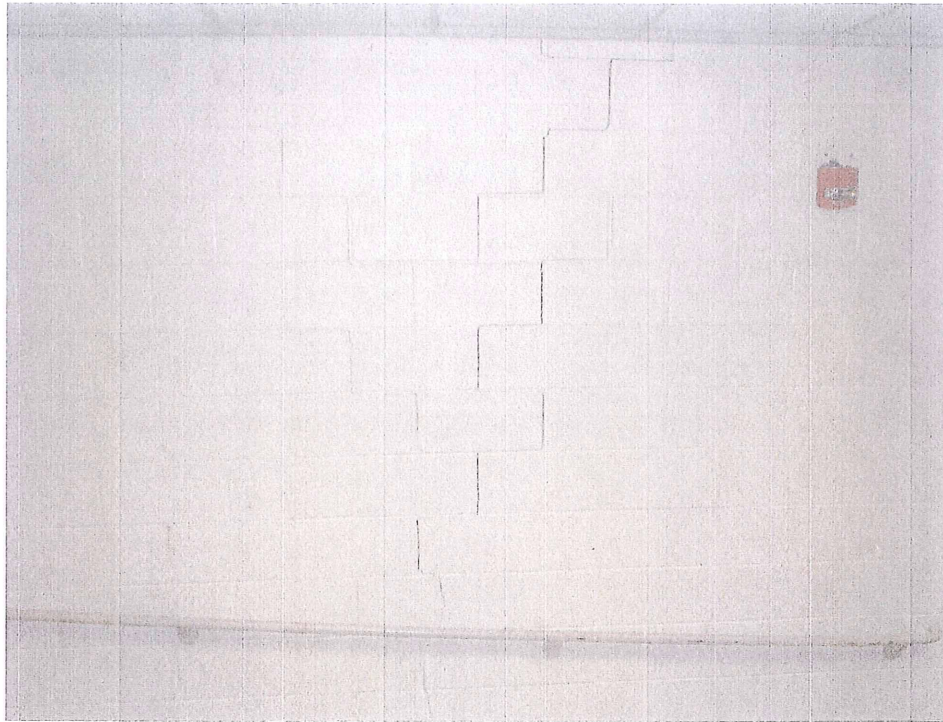
PHOTO 9 - Interior Crack At Stairs To Auditorium Stage(At Side Wall)

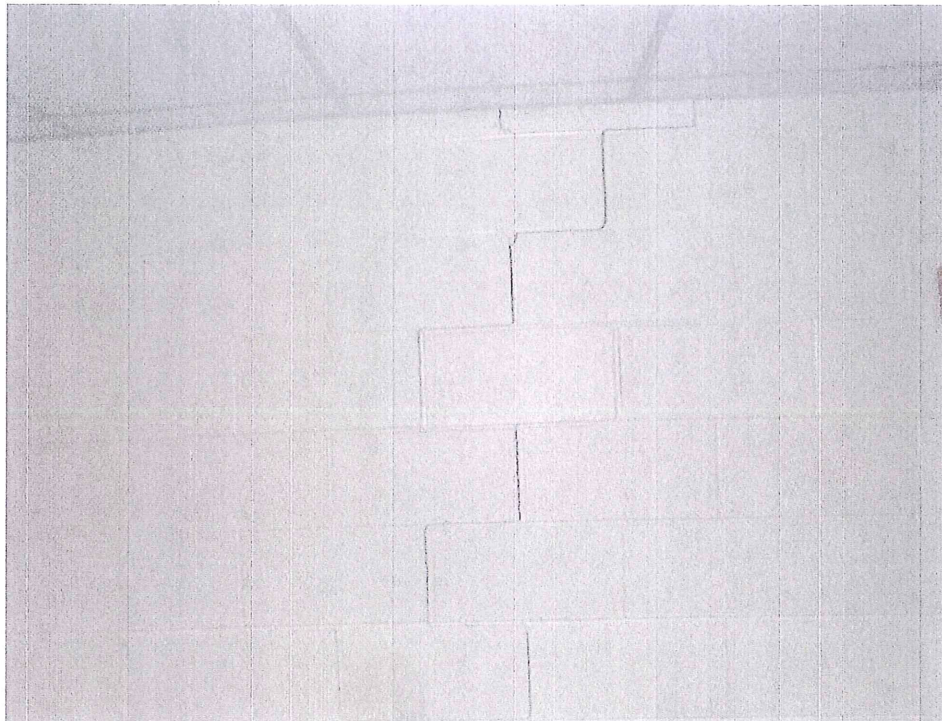
PHOTO 10 - Close Up of Interior Crack At Stairs To Auditorium Stage(At Side Wall)

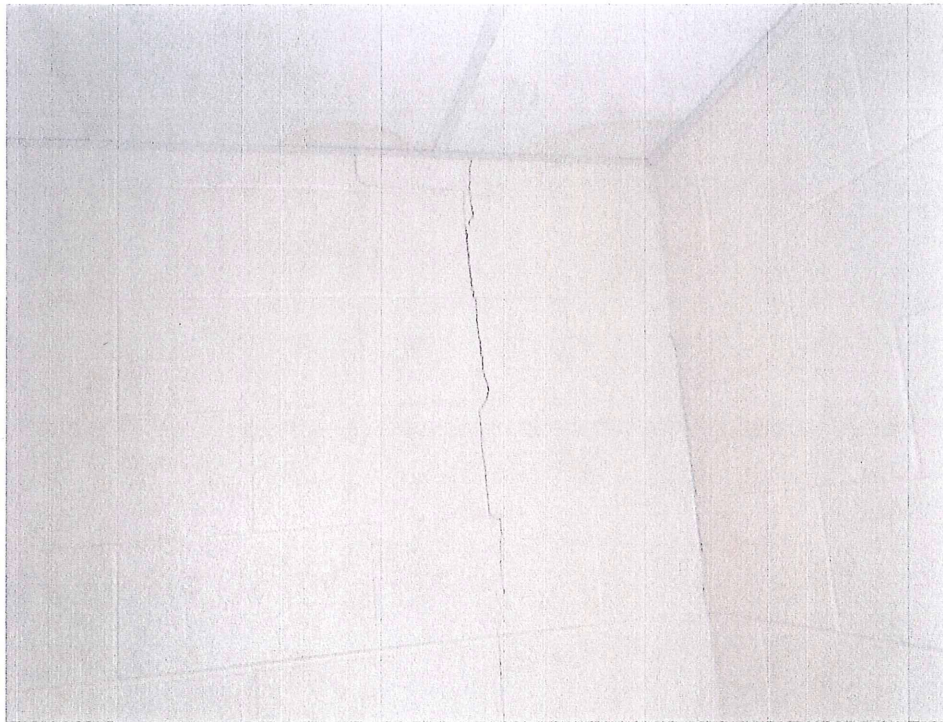
PHOTO 11 - Interior Crack At Stairs To Auditorium Stage (Near Rear Wall)

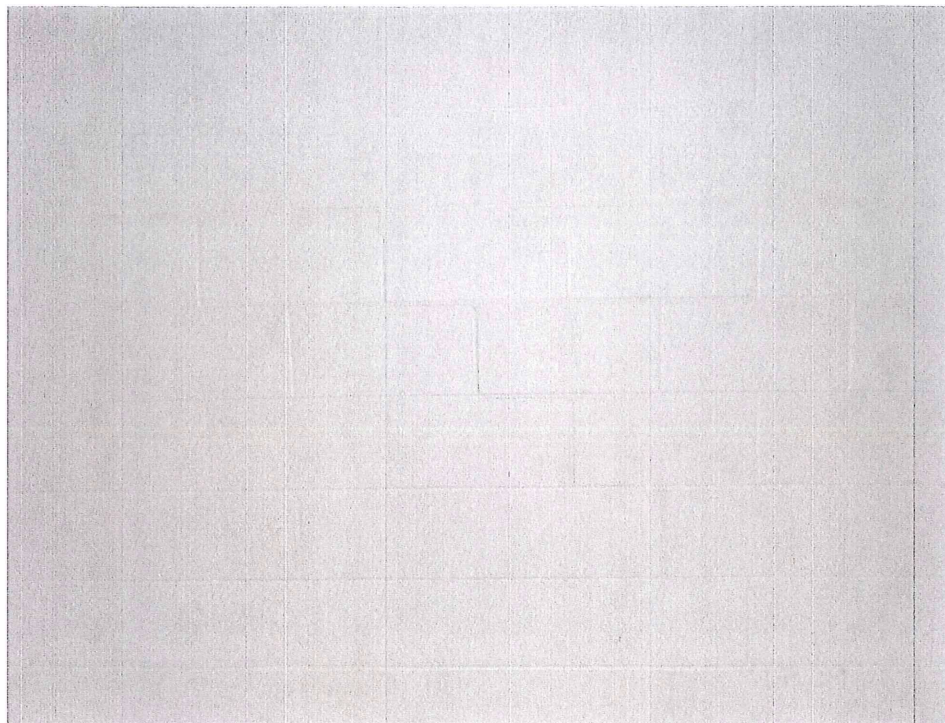
PHOTO 12 - Interior Crack At Stairs To Auditorium Stage(At Side Wall)

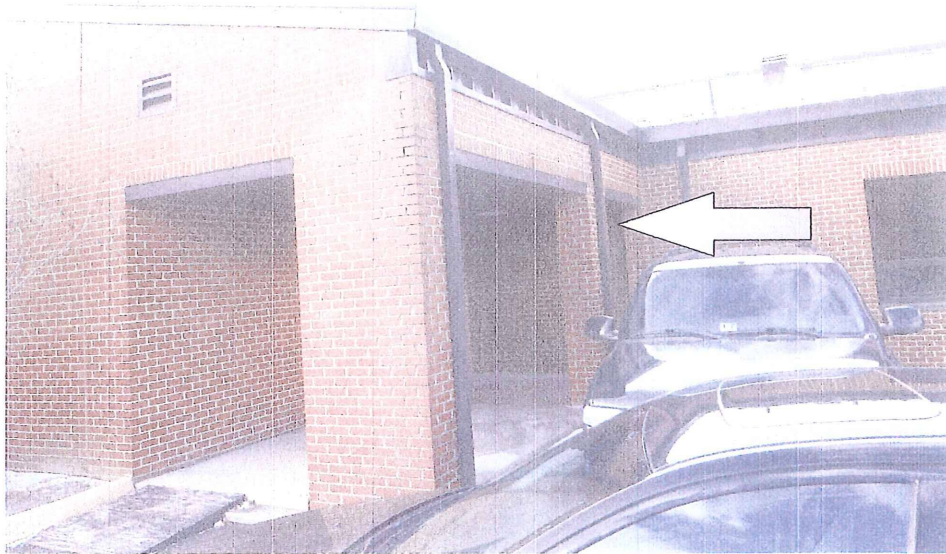
PHOTO 13 - Location of Column Shown in Photos 14m, 15 & 16

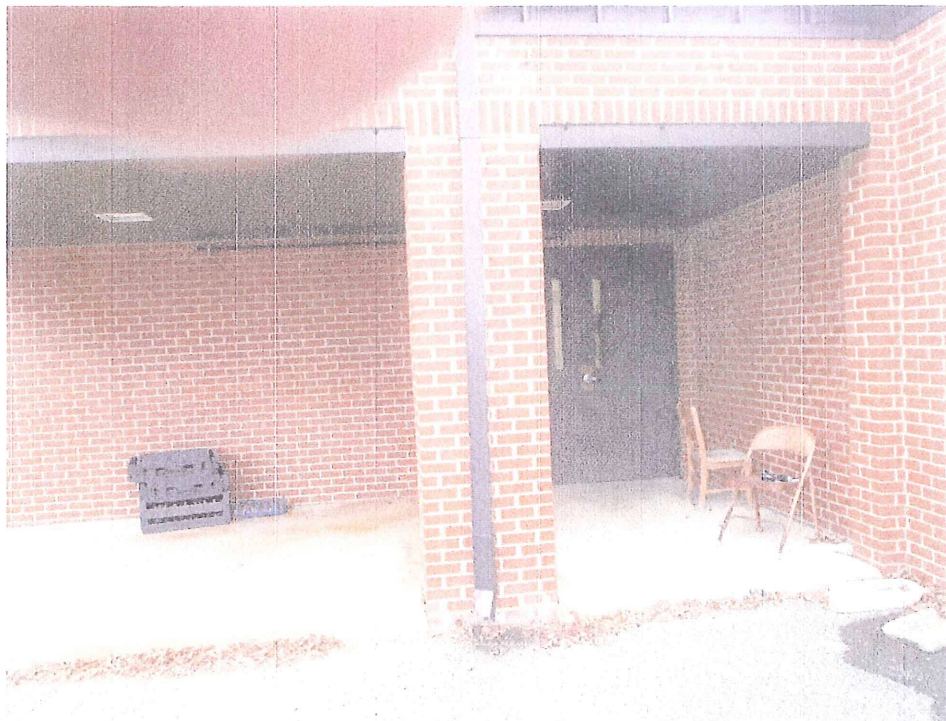
PHOTO 14 - Brick Column Shown in Photos 15 & 16

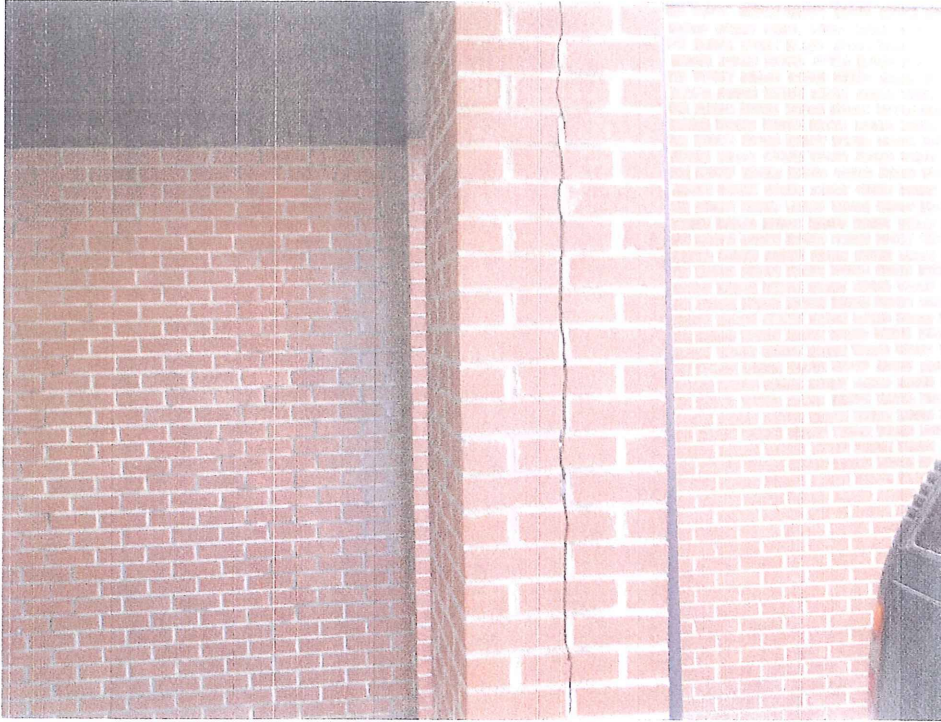
The center column at this area has a vertical crack down the middle on both sides. See photos 15 & 16. Again, there were roof problems at this area in the past and it is believed that the masonry has an old drain within its interior which is no longer used. The problem here is caused by moisture within the cavity freezing and the subsequent swelling broke the masonry as you can see. I looked at this column about a year ago and it doesn't appear that the cracking has gotten any worse. I could not ascertain if there was a structural column within the masonry. If there is one, the brick can likely be removed and replaced as long as the lintel above it bears on the column and not the masonry. If there is no column, the roof and adjacent masonry can be shored up and the brick removed and replaced.

PHOTO 15 - Vertical Crack In Brick Column

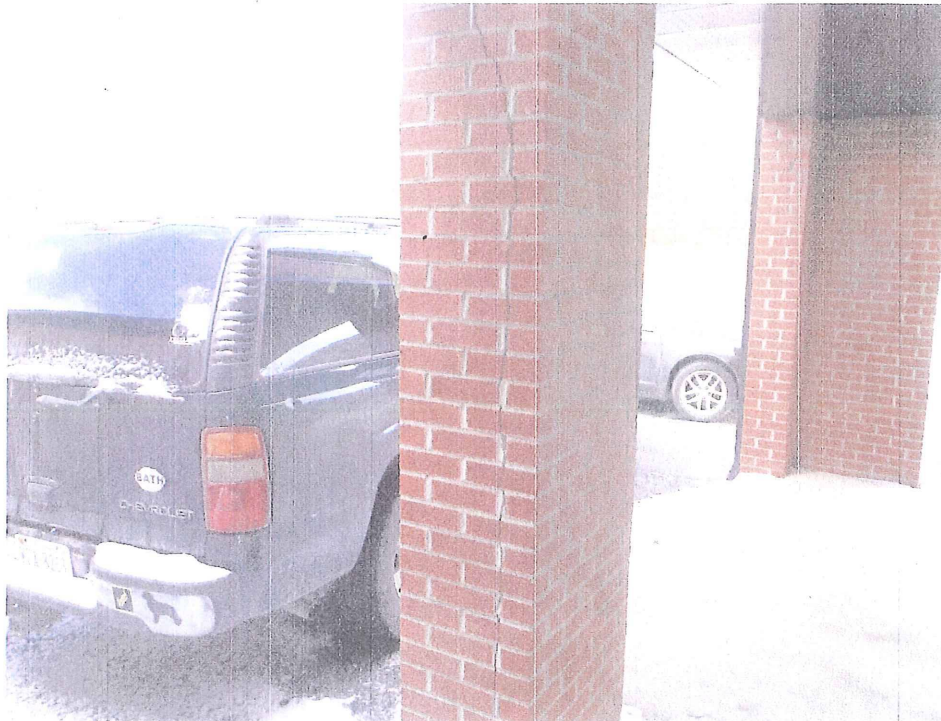
PHOTO 16 - Vertical Crack In Brick Column

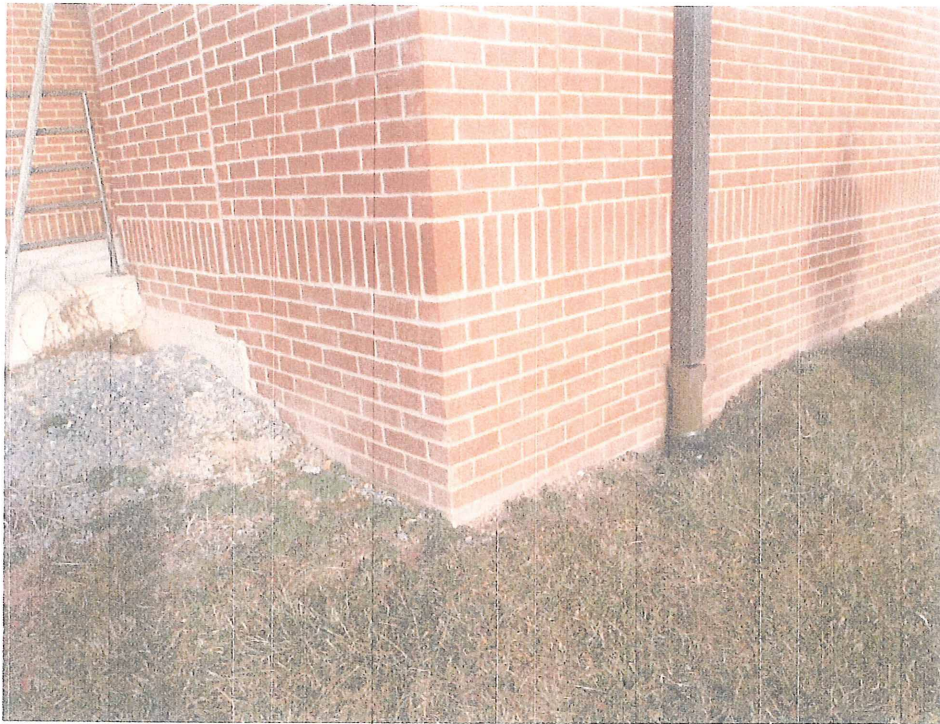
I looked at this corner about a year ago and the downspout was draining directly on the ground and I instructed you to have the drain repaired. See Photo 18. This was done and it appears the problem has fixed itself since I could not see any movement by a simple visual assessment. It appears the corner is stable, but the section of wall over the entrance appears to have settled more than the corner. You indicated that some work was done on the corner in the past to address this condition, but none on the adjacent area on each side of the entrance. The entrance distributes the load from the wall to each side, therefore loading the foundation on both sides of the entrance more than between. This differential movement shown in Photo 20 is the cause of the cracking shown in Photos 19, 21, & 22.

PHOTO 17 - Gymnasium Corner Showing Differential Settlement

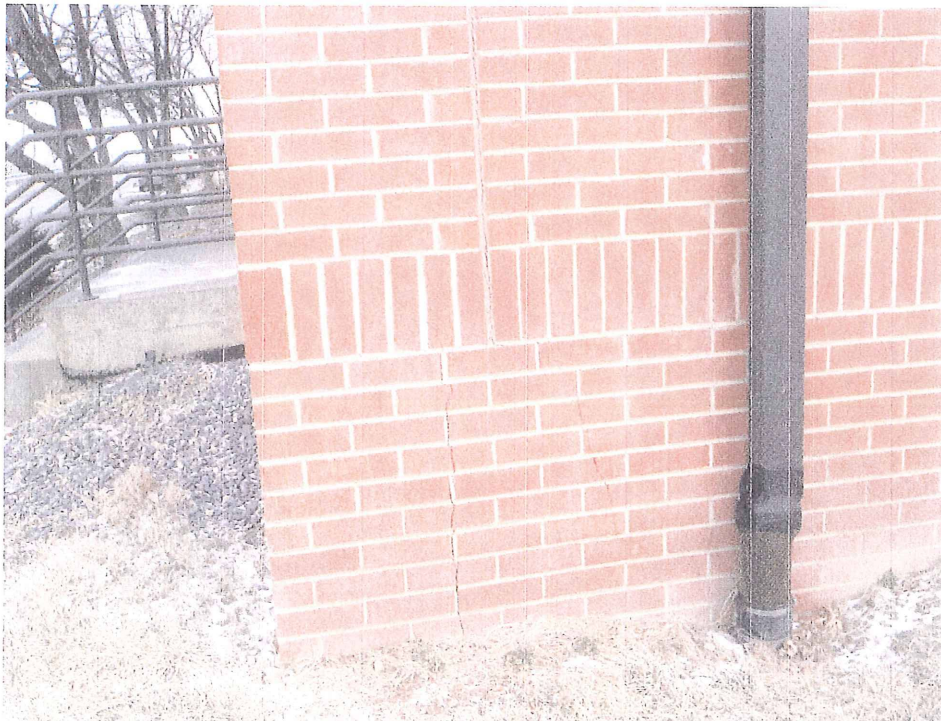
PHOTO 18 - Downspout is Likely Cause of Settlement At Corner

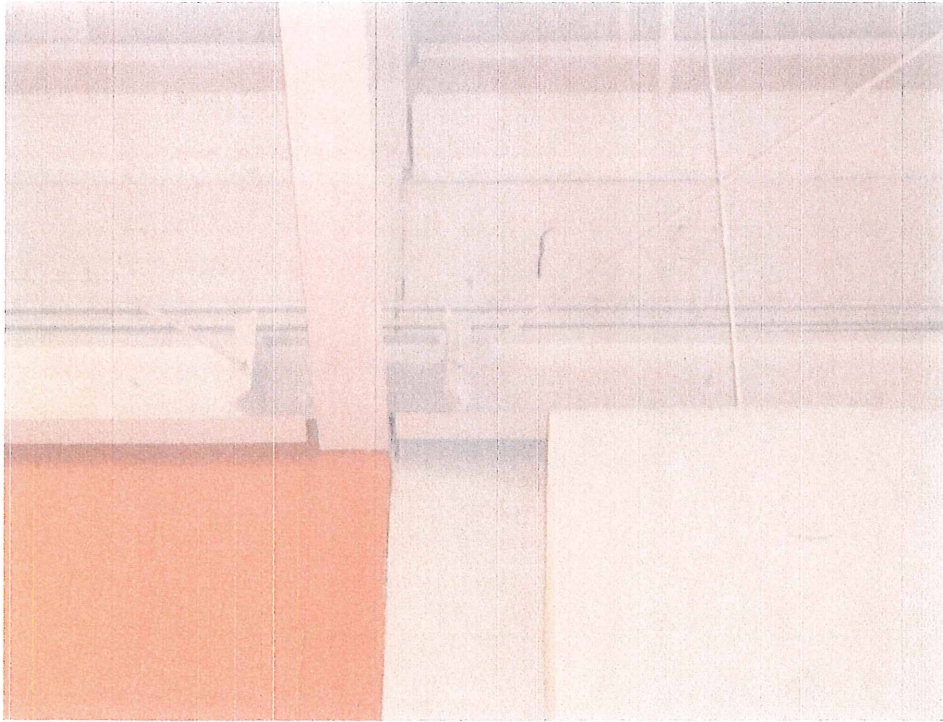
PHOTO 19 - Step Crack In Sidewall Of Gym Resulting From Corner Settlement

I recommend installing crack monitors on the cracks within the gymnasium as well as on the exterior of the wall shown in Photo 20. We will measure these after installation and again in 6 months to a year to see if any additional movement is occurring. If movement is still occurring, I would recommend reinforcing the foundations there with the helical piers mentioned earlier in this report. The crack monitors in the gym now show movement and are quite deteriorated. Their original readings are not known so their readings are of no value for evaluating the settlement.

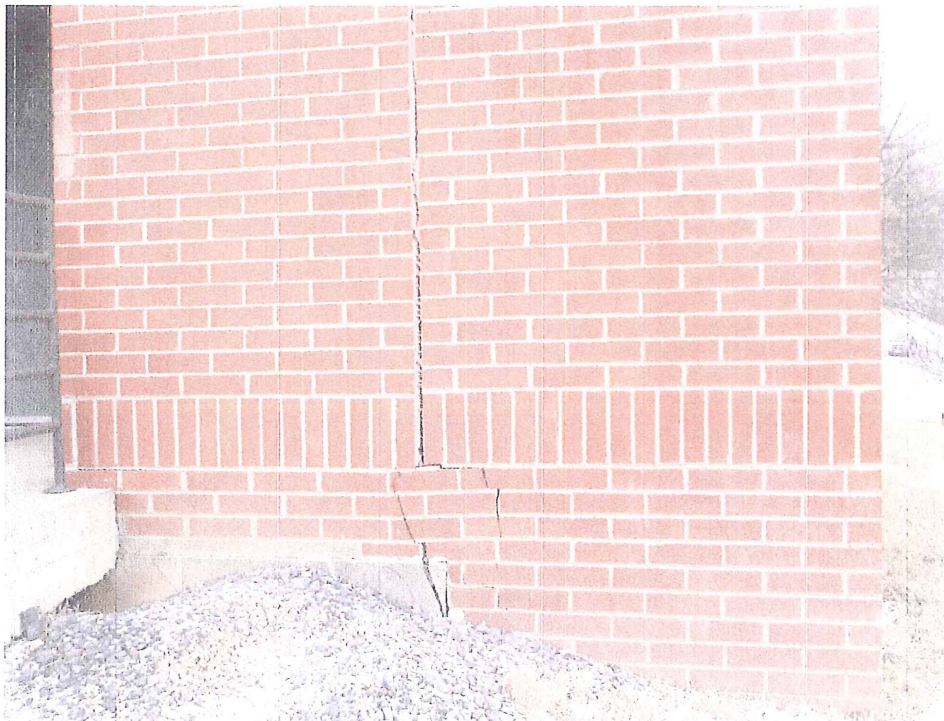
PHOTO 20 - Settlement of Wall Left of Corner

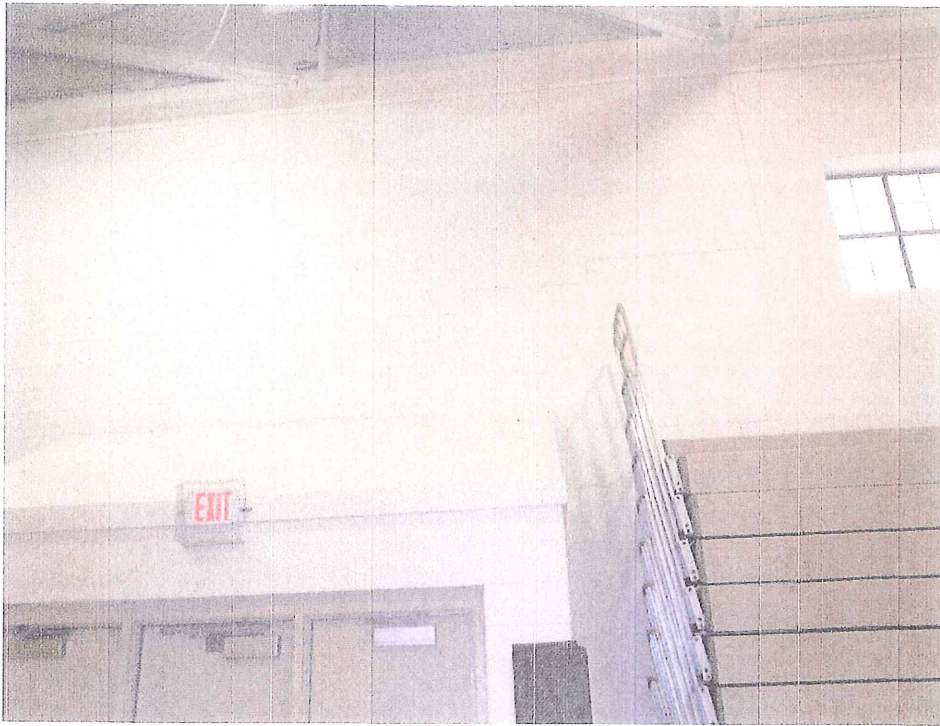
PHOTO 21 - Horizontal and Diagonal Cracking Above Bleachers

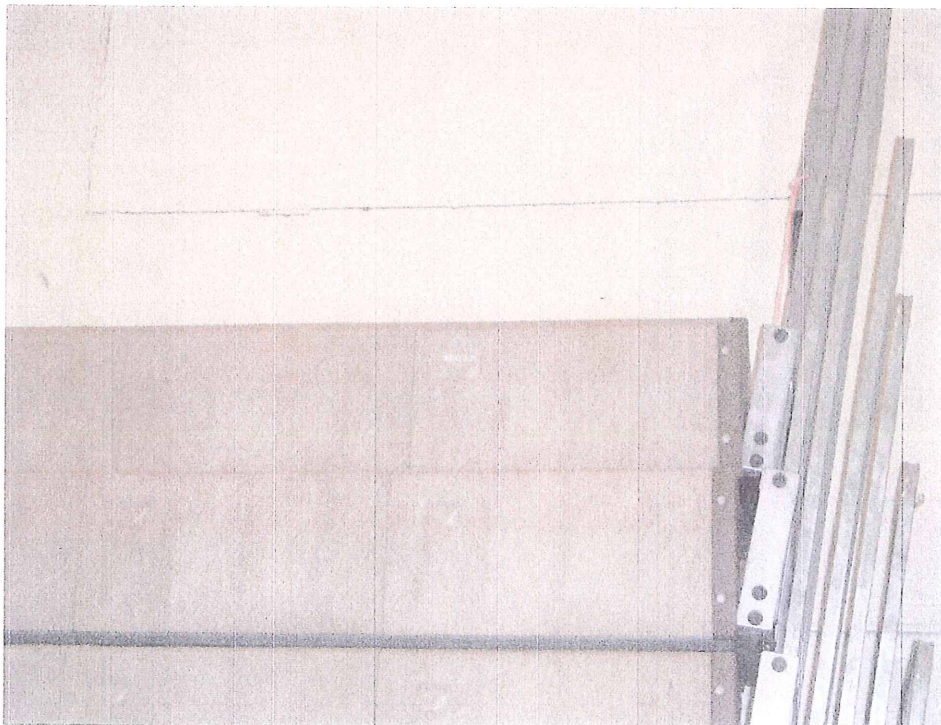
PHOTO 22 - Horizontal Crack Above Bleachers (Close Up of Photo 21)
